INSPECTION DATE 2026-10-22	MILEAGE 107251 km	ENGINE 3.6L 6 Cylinder	FUEL Petrol
TRANSMISSION Automatic	COLOUR Gray	VIN 1C4JJXFG9NW184289	REGIONAL SPEC American
NUMBER OF KEYS 1	SPARE TYRE Available

Report Summary

GOOD, MINOR ITEMS NOTED

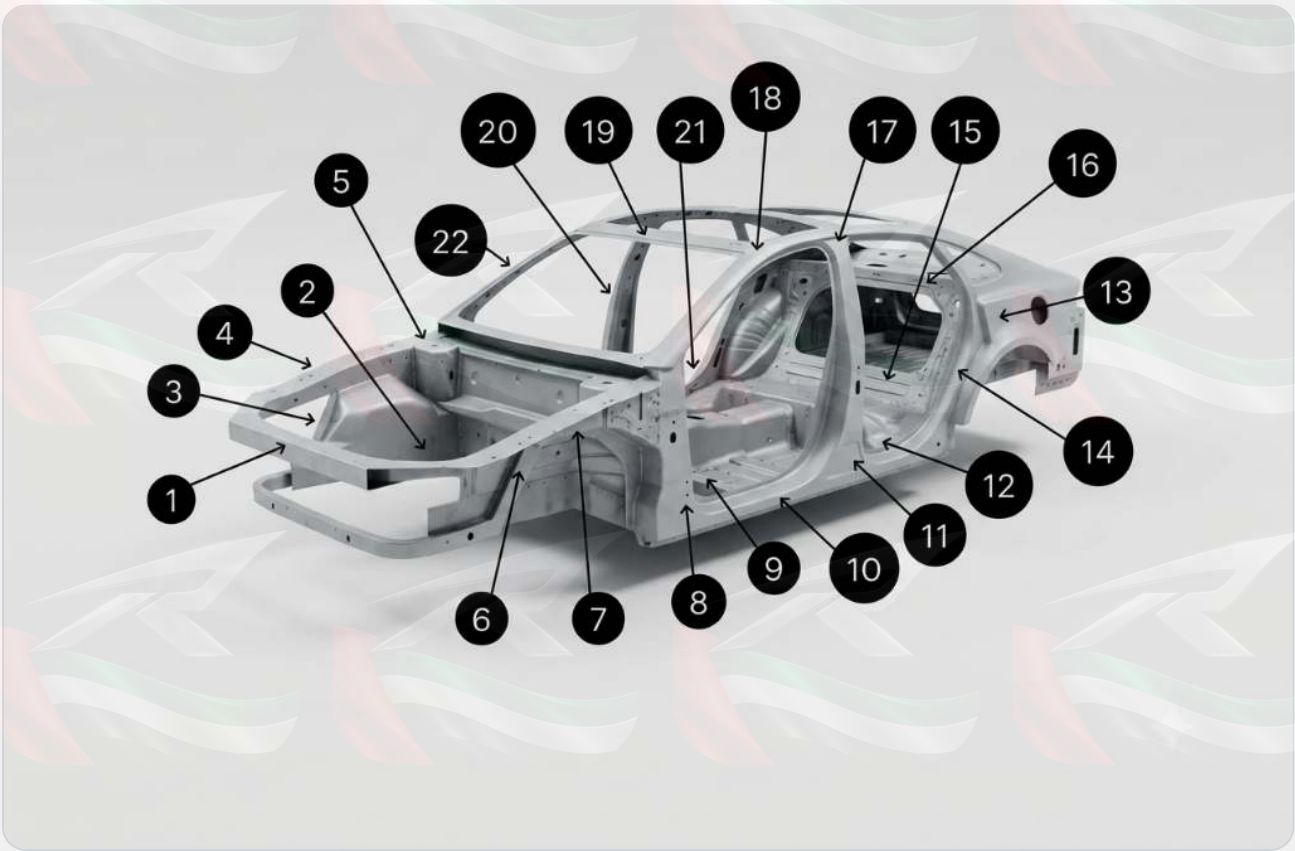
CHASSIS, PANELS & PILLARS

PASS

No chassis, panel or pillar issues found. All visible structural areas inspected and confirmed clear.

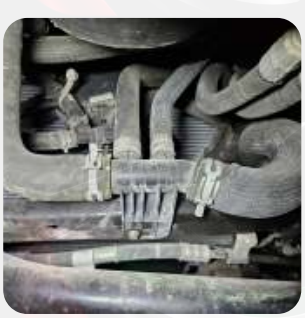
ENGINE BAY & UNDERCARRIAGE

Engine Leaks	FAIL
Leak from rear main seal

Turbo/Supercharger	N/A
Drive Belt	PASS
Hoses	FAIL
Coolant leak from coolant hose

Mechanically, the car has an engine oil leak from the rear main seal and two minor coolant leaks from the hoses. These issues need to be fixed.
